# **Structural Inspection of Existing CSX Bridge at Kanawha River Charleston, WV**

**Environmental Design Group  
1329A Quarrier Street  
Charleston, WV**

**January 5, 2004  
Revised January 14, 2004**

Subject: Preliminary Structural Inspection of the Existing CSX Bridge, Charleston, WV

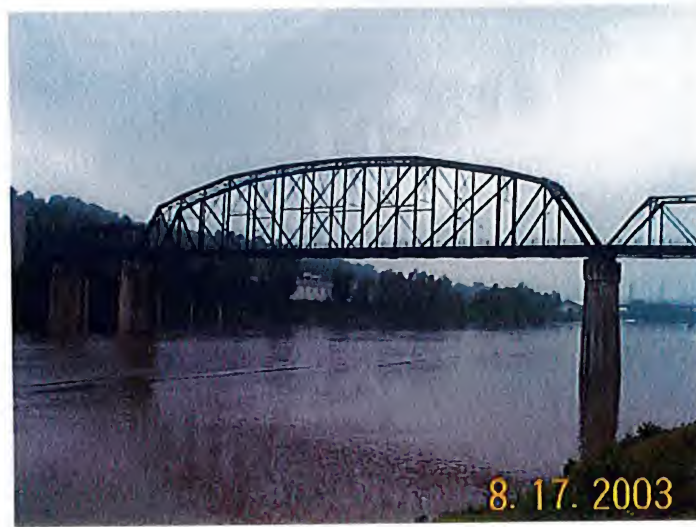
Elevation of Main Span crossing  
Kanawha River, looking  
downstream

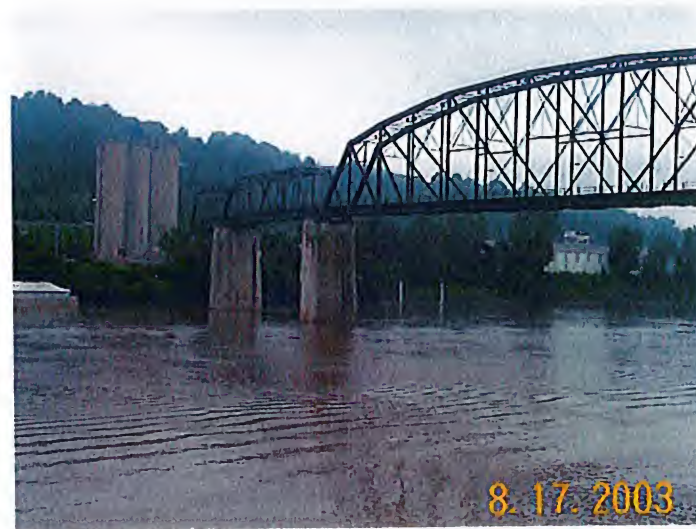
South Approach Trusses and  
concrete river piers, looking  
downstream

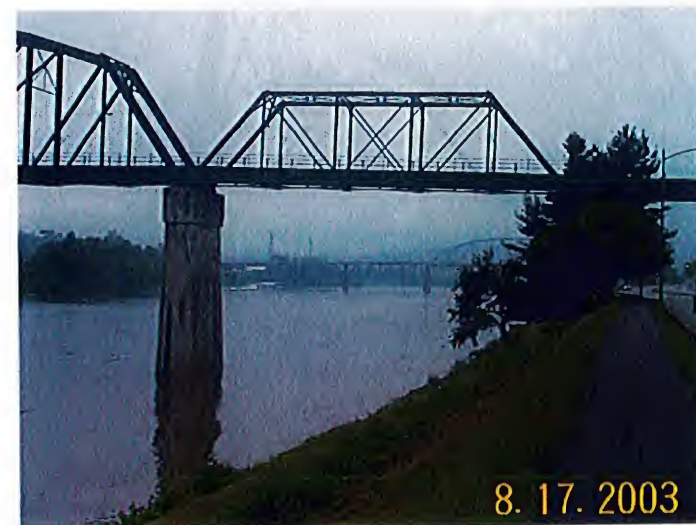
North Approach Truss

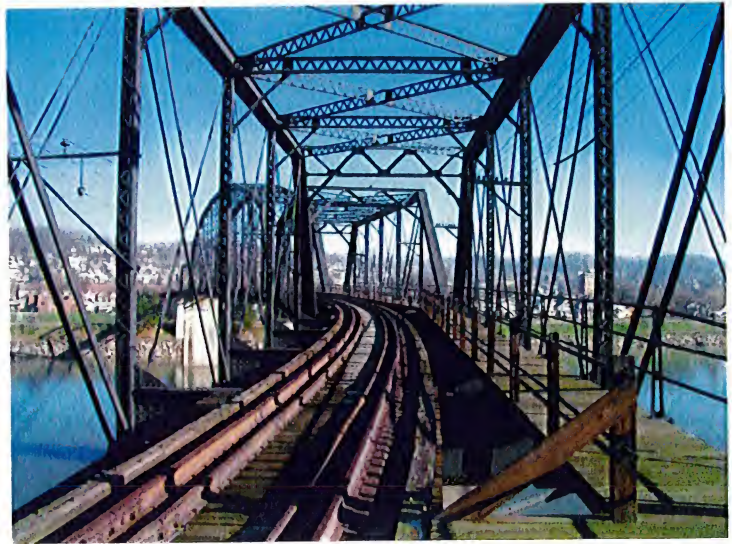
View thru South Truss showing track and walkway on the upstream side of the bridge. The existing wood deck and handrails will have to be replaced.

Remove the existing wood walkways located inside of the trusses and upriver of the railroad tracks. The deck can be replaced in kind or in specific sections as determined later.

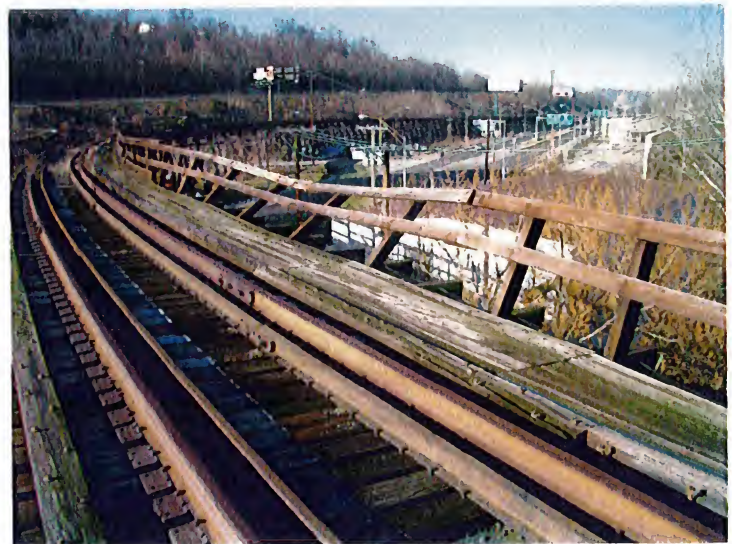
Both the north and south wood trestle and steel girder approach spans have a wood sidewalk and handrail cantilevered from the west side of the tracks. This sidewalk and handrail is in very poor condition and should be removed completely from the structure. At present, the existing sidewalk does not appear to be physically attached, just a wood stringer that extends parallel to the crossties and bears under the rails, preventing uplift of the sidewalk stringer.

Failing handrail and walkway at the South Approach spans. The existing walkway and handrails should be removed.

Remove the existing wood walkway and handrail system on both the north and south approaches due to their poor condition. This walkway and handrail will be replaced with a new walkway system.

Remove the existing wood sidewalk and handrail system from both the north and south approach spans. The existing walks will not be replaced. It is assumed that most of the demolition work will be done by crane from grade.

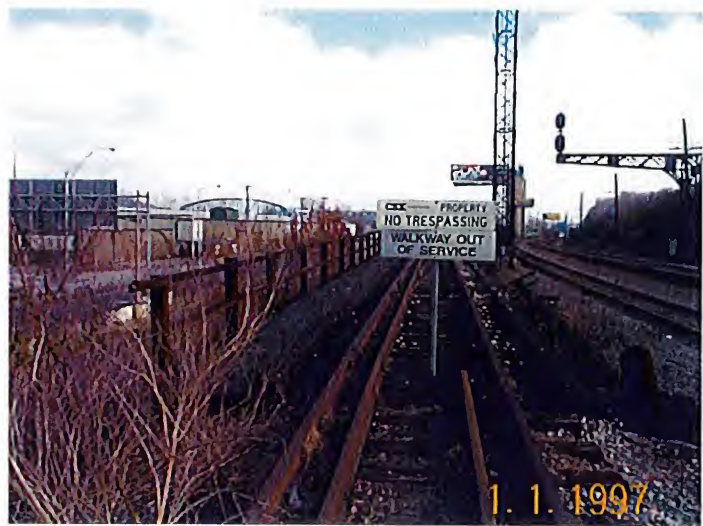
South End of South Approach  
Trestle

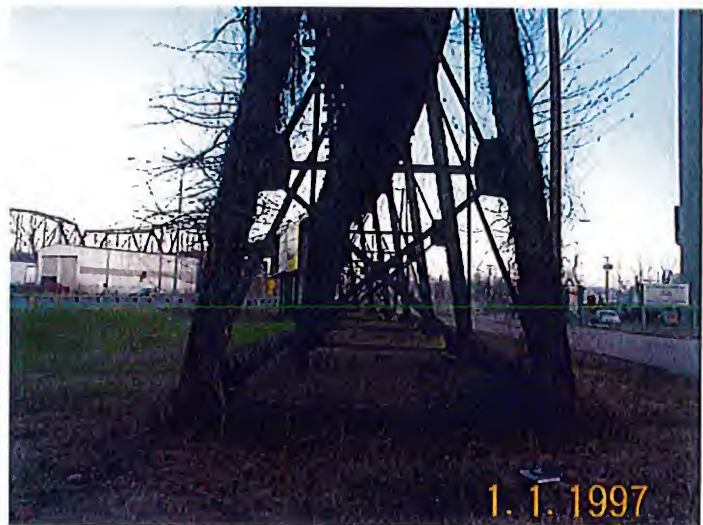
At the south approach, extensive vegetation and poor site drainage are causing problems at the wood trestles and the steel bents. The structural steel base plates and anchor bolts of the steel bents are partially covered with vegetation and, in several locations, are below existing grade and exposed to standing water. The existing vegetation should be removed and the site graded to allow for drainage away from the existing structure and to

Heavy Vegetation in and around steel  
bents at South Approach

allow 6 to 12 inches of clearance between the final grade and the top of concrete piers.

Clear and grub the existing vegetation from the south approach of the bridge from the south abutment to approximately MacCorkle Avenue. Regrade the entire area so that the top of concrete at all foundations is at least 6 inches above the surrounding grade. Provide new drainage piping as required to accommodate revised site grading. Power wash all of the structural steel base plates and the top of existing concrete foundations.

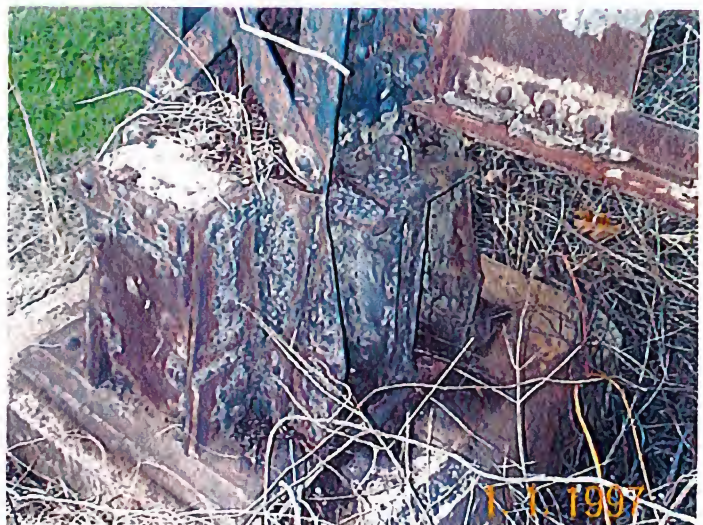
Deteriorated Base Platform  
Connection at South End

Remove damaged and deteriorated steel sections at the base plates, the lower sections of the steel bents, and the bracing, and replace with steel of a similar size and section. Work is assumed to include abatement of lead based paint on the lower 10 feet of the steel bents.

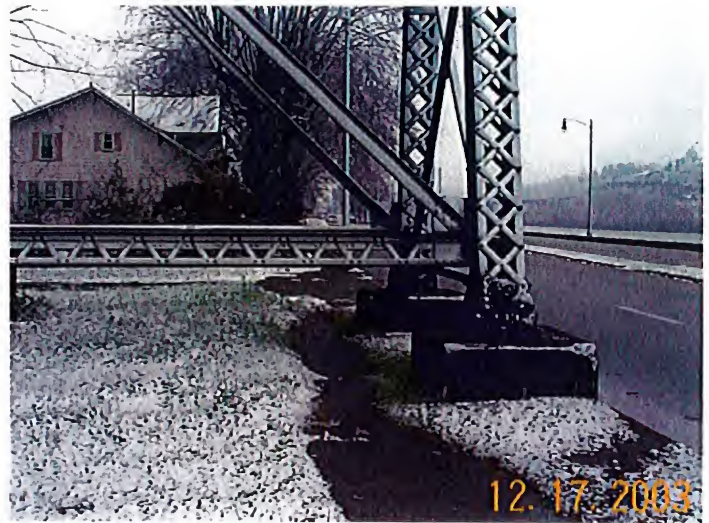
Bracing Blocking Kanawha Blvd.  
Sidewalk. This brace can be raised or  
relocated to provide adequate headroom  
for pedestrians.

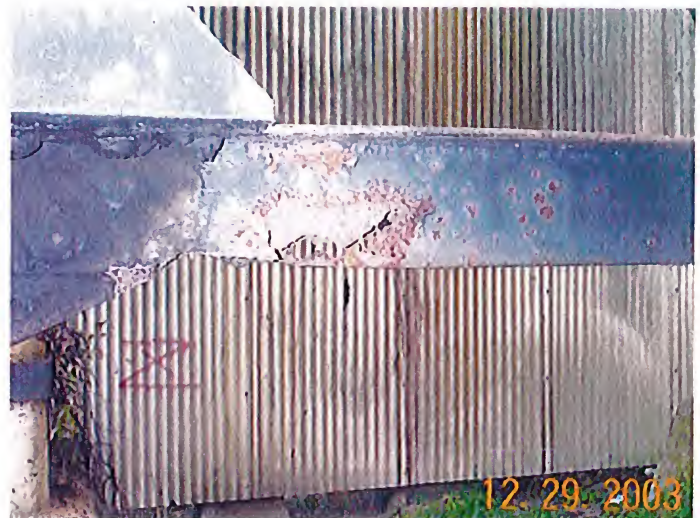
In the existing steel bents near Second Avenue, there were at least two anchor bolts that were observed to be completely rusted through, and in one case, missing. In the same steel bent, the bottom steel angles of the existing bent are almost completely rusted through. If both the anchor bolts and the bottom steel angles are ineffective, a structural stability problem may be created in the existing bent. Similar problems may be found in other bents, obscured now by soil, debris, and corrosion.

Deteriorated bottom steel tie at Second  
Avenue Crossing. This steel member  
will have to be replaced.

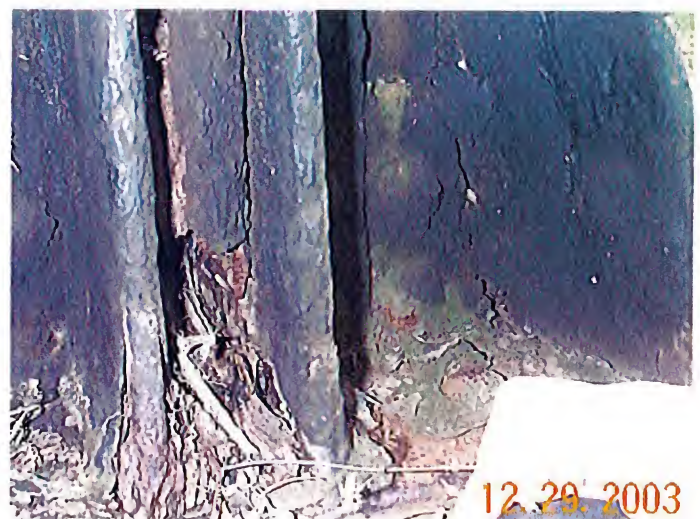
Deteriorated Anchor Bolt near Second  
Avenue Crossing. Note that the lower  
half of the bolt is gone.

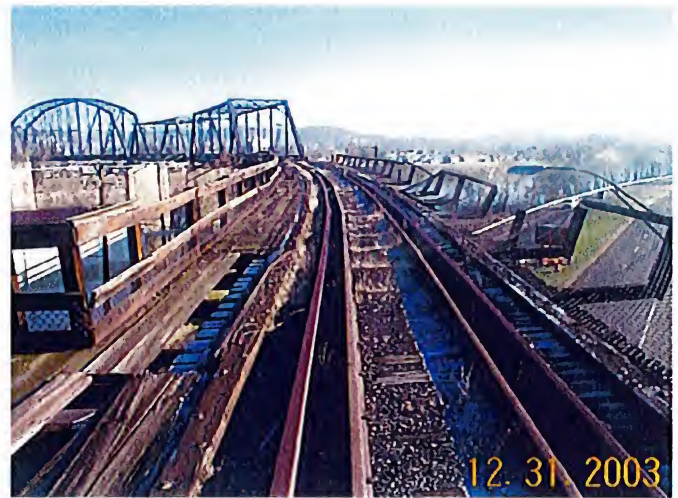
Many of the existing wood cross ties in the MacCorkle Avenue crossing may be in poor condition since they were installed without lateral clearances to prevent material from falling off the train and through the bridge. This has allowed dirt and gravel to accumulate on the ties and has allowed vegetation to grow on the tracks. Ties in this area should be cleaned off and thoroughly inspected for rot and damage due to vegetation.

Ties are closely spaced to prevent material from falling through to MacCorkle Avenue has allowed vegetation growth causing possible tie damage. Note missing boards at the walkway to left.

used to replace some of the deteriorated cross ties. Most of the existing wood cross ties across MacCorkle Avenue and Kanawha Boulevard will have to be replaced.

Remove and replace approximately 5 percent of the damaged and deteriorated treated wood crossties with treated wood crossties of a similar size. Some good existing wood crossties may be displaced by the handrail installation and available for replacement.

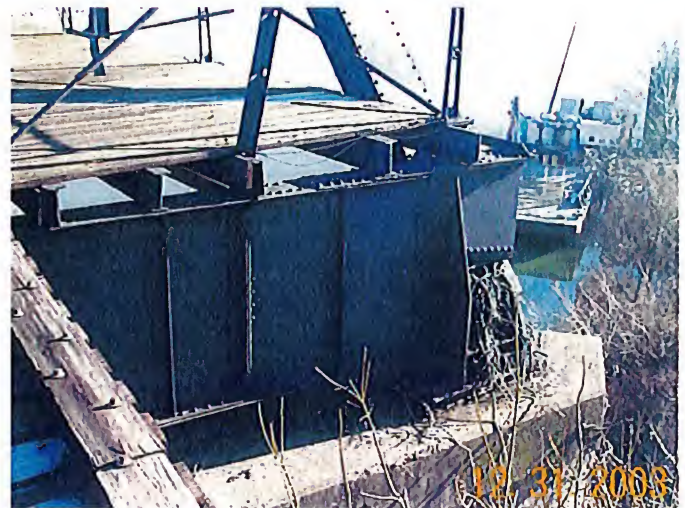
End View of South Truss showing Framing for Pedestrian walkway, looking north.

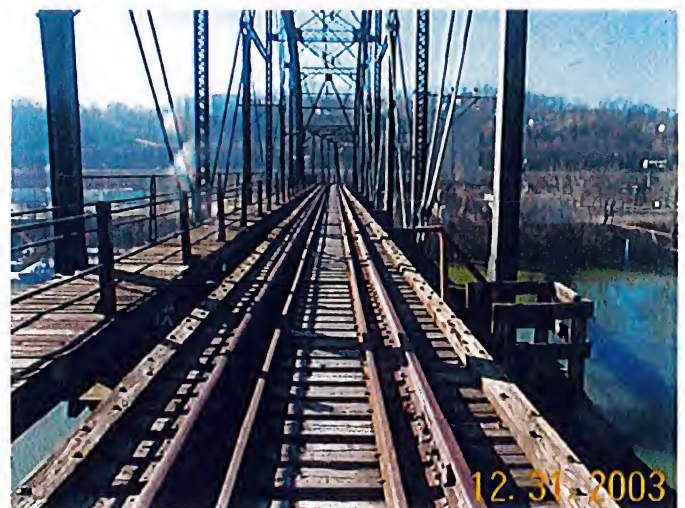
Section View at Main Truss showing Tracks and Walkway, looking south.

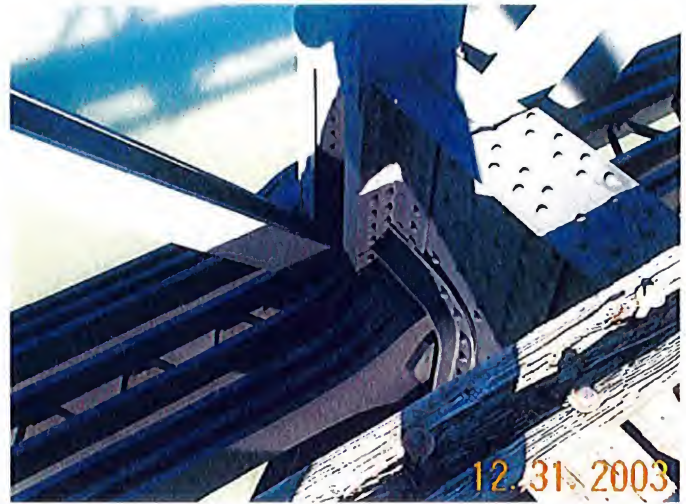
Bottom Chord of Main Truss showing  
eight (8) Eye Bar Truss members.  
Selected number of joints should be X-  
rayed to verify member capacity

X-ray selected pin connected steel eyebars at the lower chord of all four steel truss spans to determine if there is any hidden corrosion or deterioration. Please note that this work should be done before the purchase of the bridge is finalized, due to the potential cost of eye bar repairs, if required.

X-ray selective eye bar joints at the lower chord panel points of all four trusses. This work should be done prior to finalizing bridge purchase.
